# Guide to Assessment and Repair of Flood Damaged Timber and Timber Framed Houses

(Revised 19<sup>th</sup> Jan 2011)

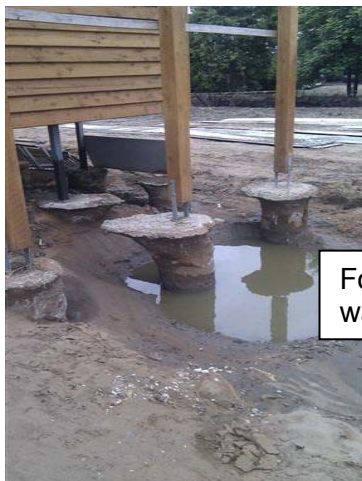
Footings scoured out by fast flowing water

Failure to address or correct these types of faults could severely affect the future structural performance of the building.

**NOTE: Where fast flowing water has impacted on the dwelling, joists and bearers may have shifted/twisted and walls and windows may be out of square etc. Any excessive misalignment should be corrected before new cladding or lining is installed.**

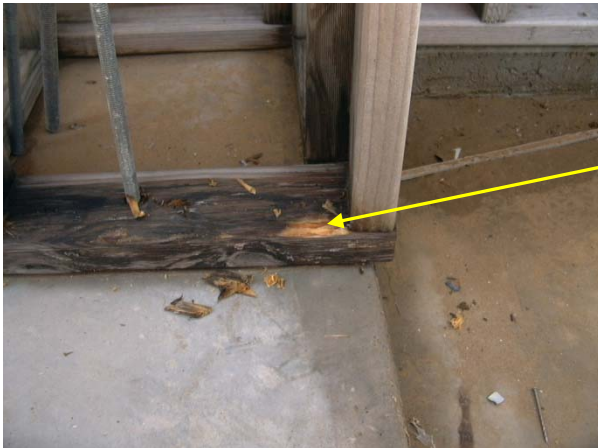
Although heavily discoloured with surface mould and blue stain, the pine timber is still sound as shown by scraping back the surface layer

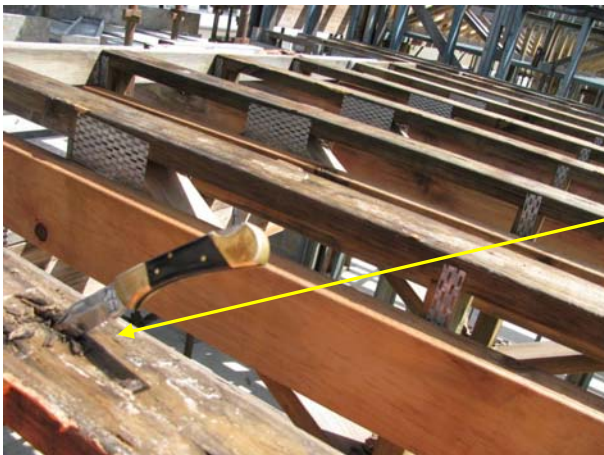
Decayed timber is soft and spongy and can easily be penetrated with a knife or screwdriver

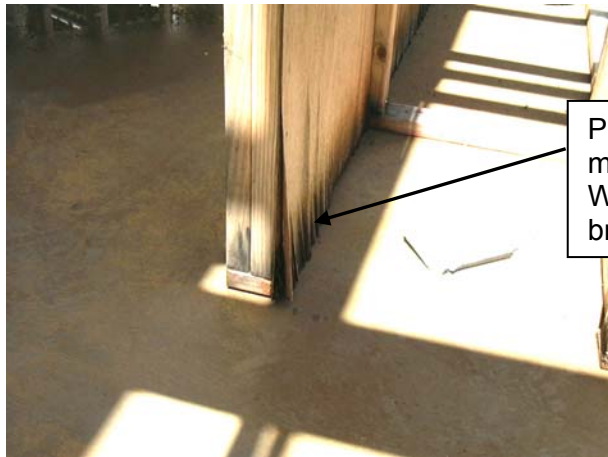
Plywood sheet bracing affected by moisture. Replacement required. Where necessary fix temporary braces.

In houses built after about the mid 1970's, **wall bracing** using wall lining materials (plasterboard, plywood, hardboard and fibre cement etc) as the brace may have been used. Where wall linings are stripped, temporary diagonal timber braces (70x35 pine) at 30° to 60° should be nailed to the top plate, bottom plate and studs to each wall to maintain the houses bracing strength prior to re-instatement of permanent bracing and wall lining.

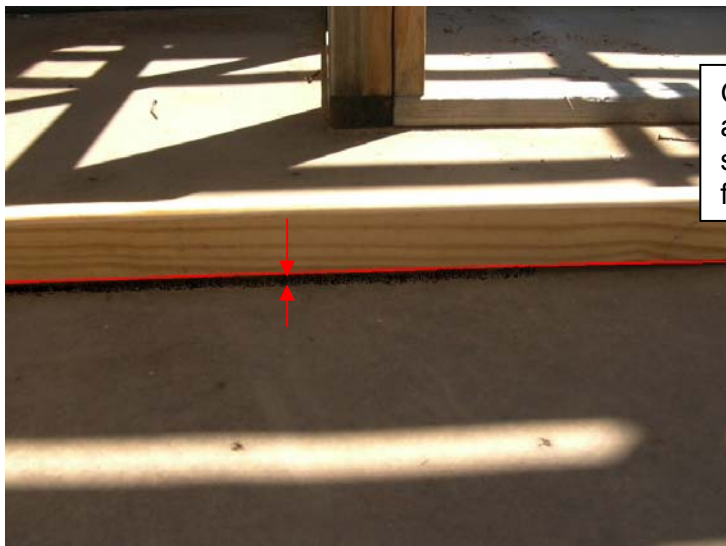
Allow the particleboard flooring a minimum of 4 months to dry out before re-assessing and any rectification that may be required. As a guide only, it is suggested that if sheet edges have swollen more than 5mm (i.e. would need to be sanded back by 5mm or more to get a flat floor) then the structural adequacy of the flooring has been compromised and needs rectification by either replacement or installation of a new structural floor over the existing particleboard.

Gap between straight edge and floor indicates edge swelling in particleboard flooring
