<p>Outdoor Structures Australia Practical solutions that enhance community design projects</p>		Date		Description	
		29/01/2003		OUTDOOR STRUCTURES AUSTRALIA INSTALLATION INSTRUCTIONS CONTINUOUS TRAFFIC BARRIER (STD.)	
Old College Road, Gotton, Queensland, Australia PO Box 517, Gotton, Queensland, Australia, 4343 Ph: (07) 5462 4255 Email: ted@outdoorstructures.com.au		Drawn J MILLARD Approved E.M.S.		Scale N.T.S.	
Fox: (07) 5462 4077 Website: www.outdoorstructures.com.au		Job No OSA		Drawing No TBPCI

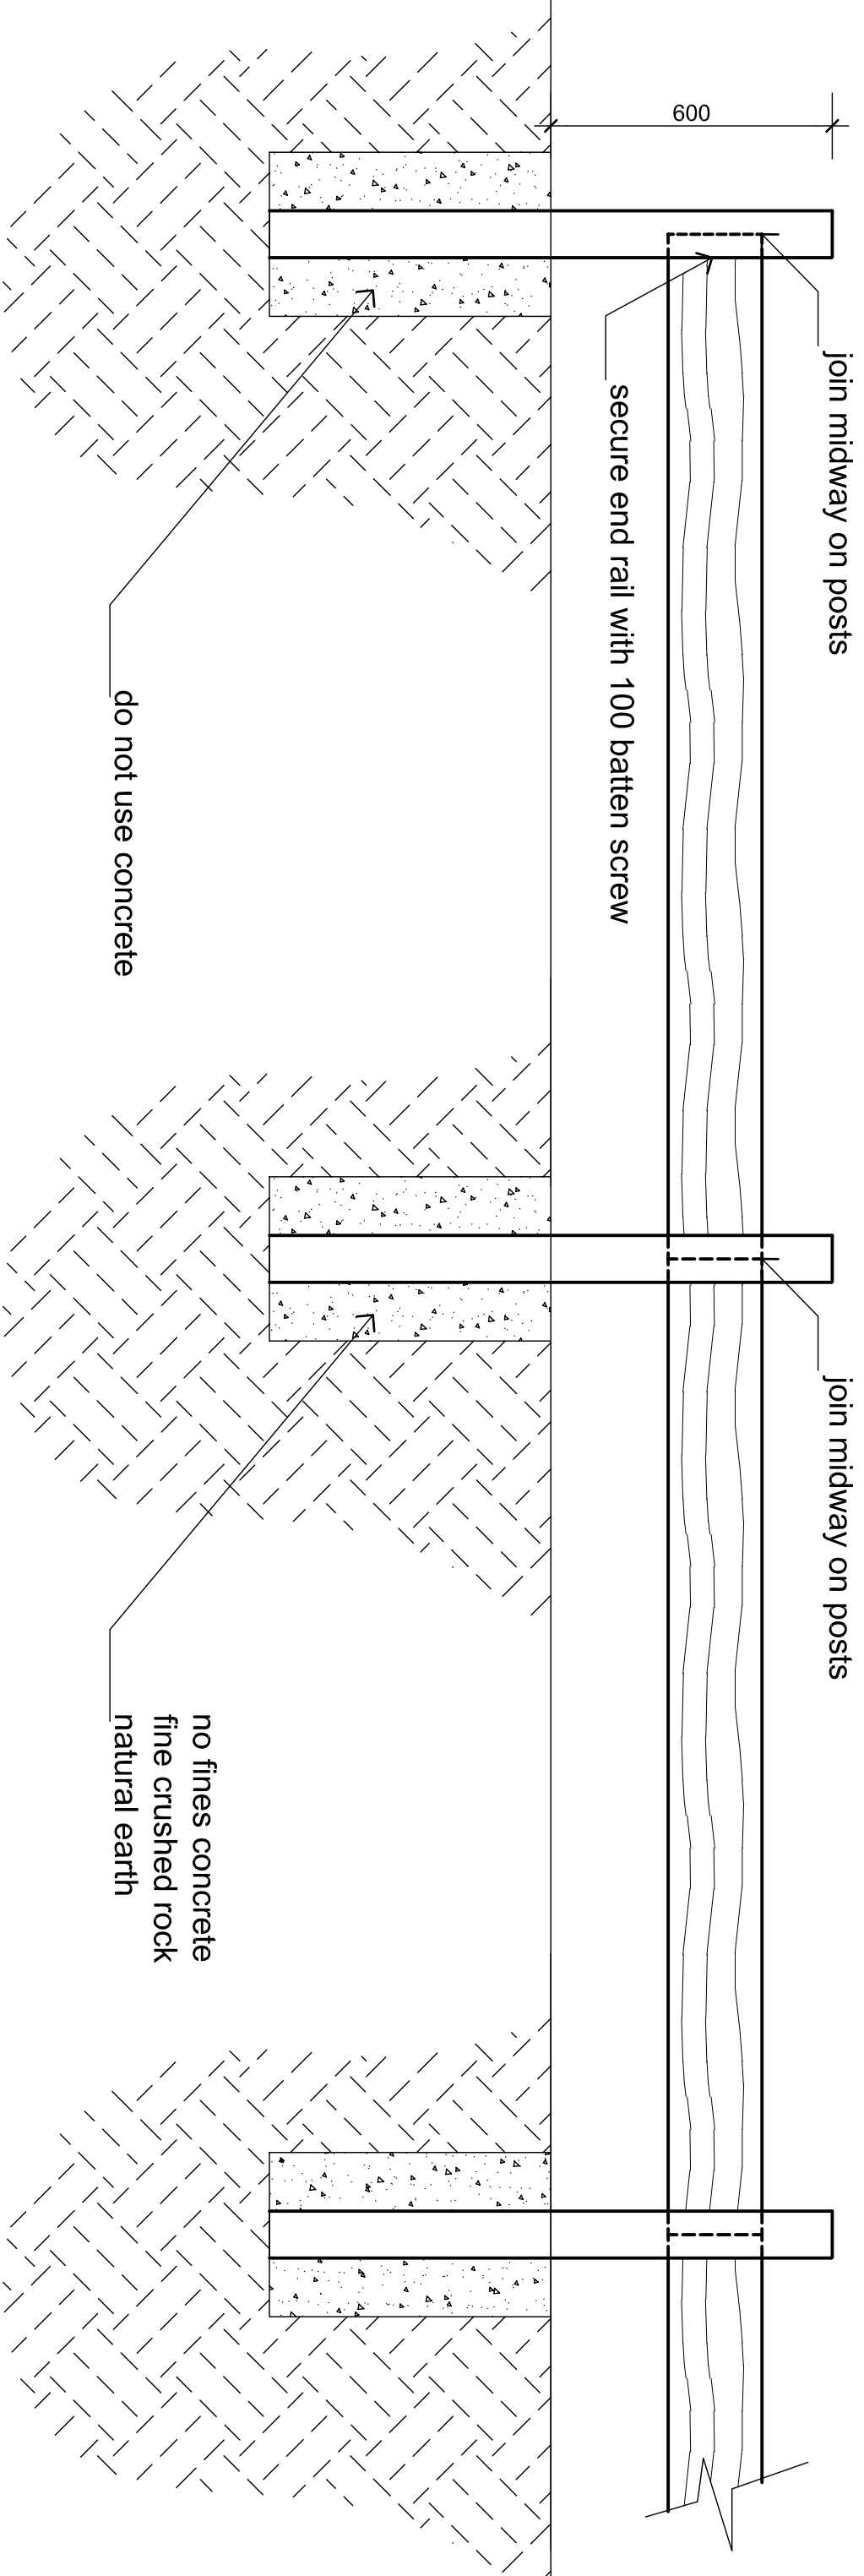
**SLOPE ON TOP OF POSTS AS DIRECTED BY CLIENT
 NORMAL ALIGNMENT IS WITH THE SLOPE TO THE FRONT
 (Screws are only required on the end posts of each run)**
